Beech Hill Pond Watershed Survey 2010

February 2011

**Hancock County Soil & Water
Conservation District**

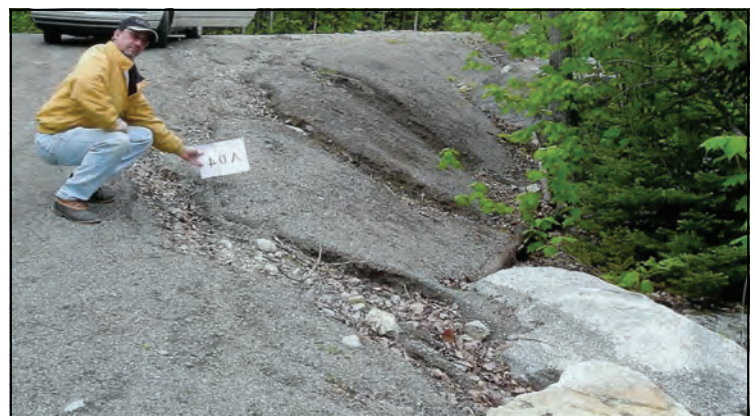
A volunteer helps to document erosion issues in the Beech Hill Pond watershed.

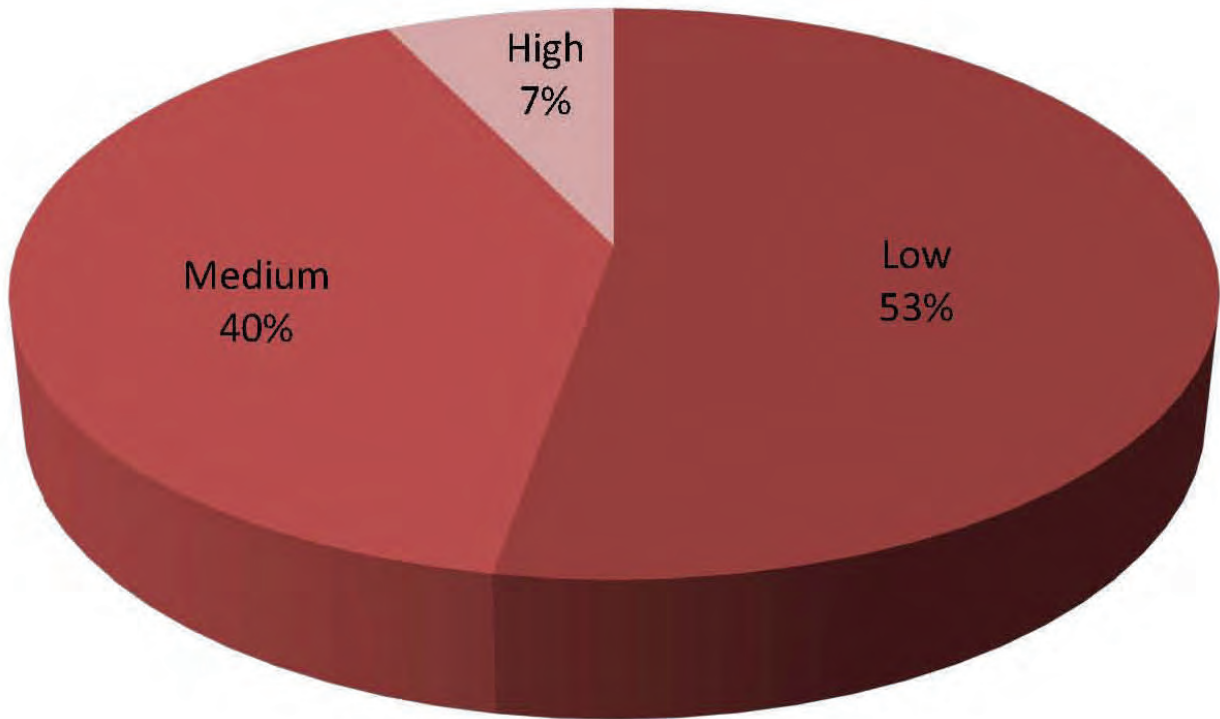
Impact to the Lake

Out of the 167 total sites, 88 were rated as Low Priority, 67 as Medium Priority, and 12 were rated as High Priority in terms of Impact to the Lake.

The findings show that most of the documented sites in the watershed are low and medium impact sites. Because of these multiple sources, many sites will need to be addressed to make a significant impact on reducing erosion issues.

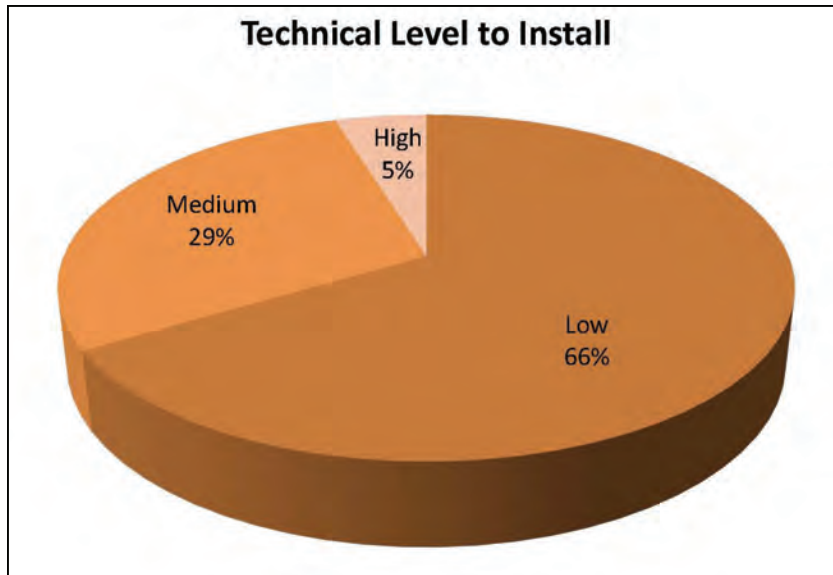
Out of the total 167 sites that were documented, 111 were designated as having a low level of expertise needed (meaning a homeowner or volunteer could install the fixes with little or no assistance), 48 a medium level of expertise (meaning a person with erosion control training could supervise fixes), and 8 were high priority (meaning the site would probably require an engineered design).

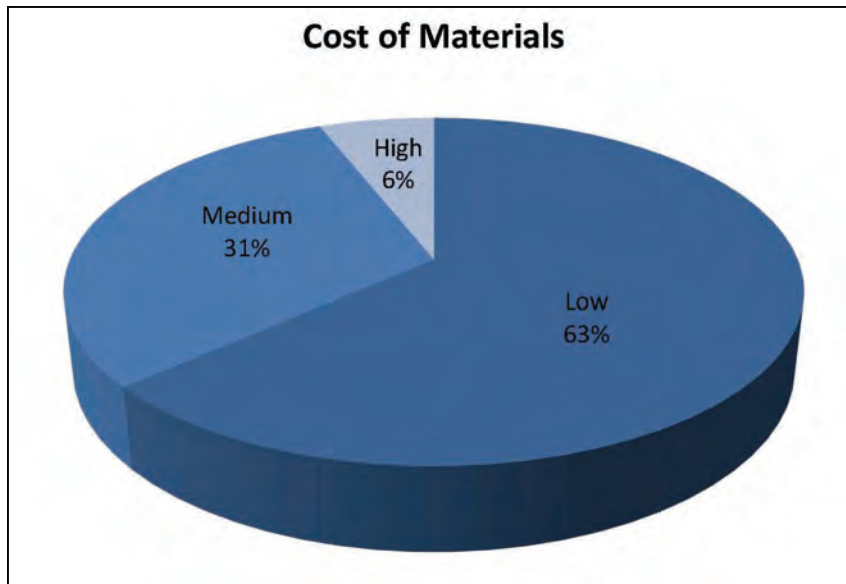
For cost of materials, a low rating is given if the project will be approximately \$500 or less, a medium rating is given to sites with an approximate cost of \$500-\$2,500, and a high rating is given for projects costing greater than \$2,500. Of the 167 total sites 106 were rated low for cost of materials, 51 sites were rated medium, and 10 were rated as high.

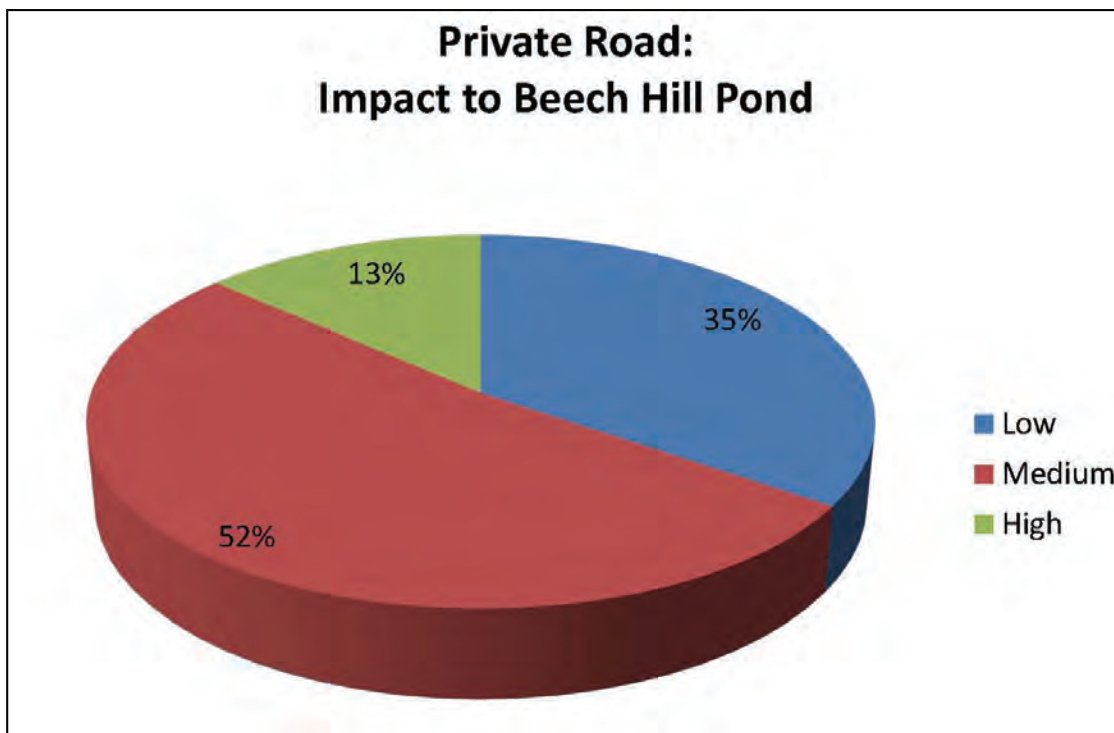
52 of the 167 sites were found on Private Roads. Out of these 52 Private Road sites, 45 sites were low or medium priorities for their impacts to Beech Hill Pond.

- Unstable culverts (inadequate size, not functioning, unstable inlets and outlets)
- Ditch and shoulder erosion
- Grader berms left behind from plowing or grading that prevent water from flowing off the road
- Surface erosion

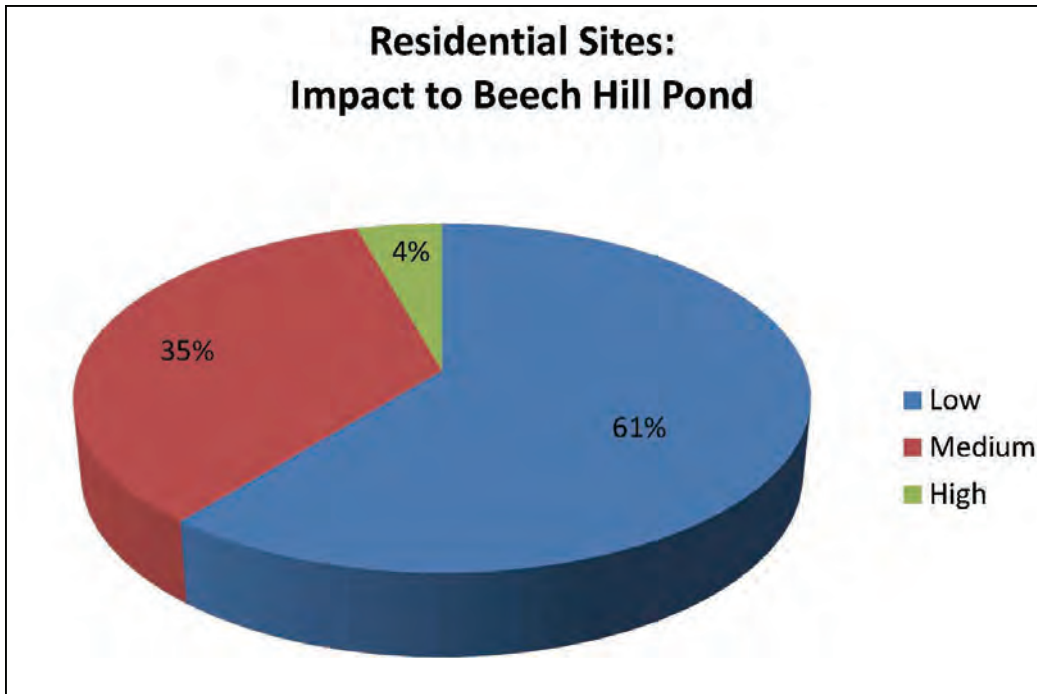
115 of the 167 sites were found at Residential Sites. Out of these 115 Residential sites, 110 sites were low or medium priorities for their potential impacts to Beech Hill Pond.

- Inadequate or lack of shoreline buffers (94 of the 115 residential sites)
- Surface erosion or bare/open soil areas
- Driveway erosion issues
- Uncovered soil piles

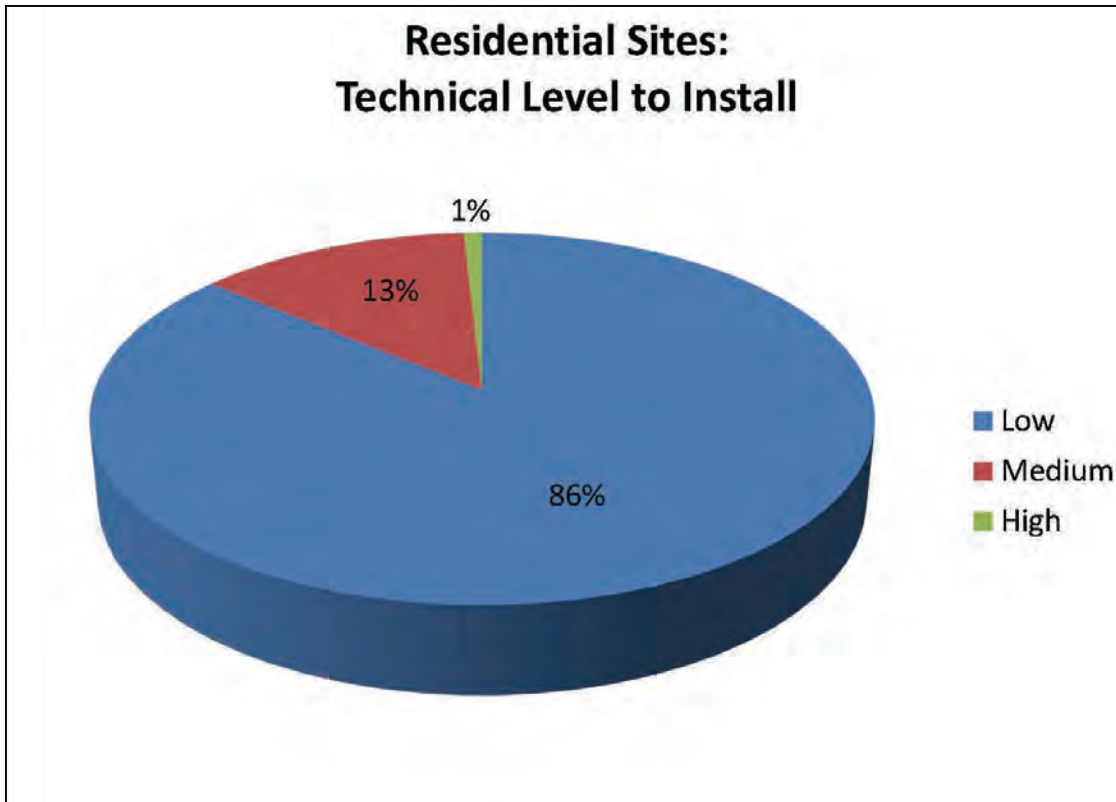
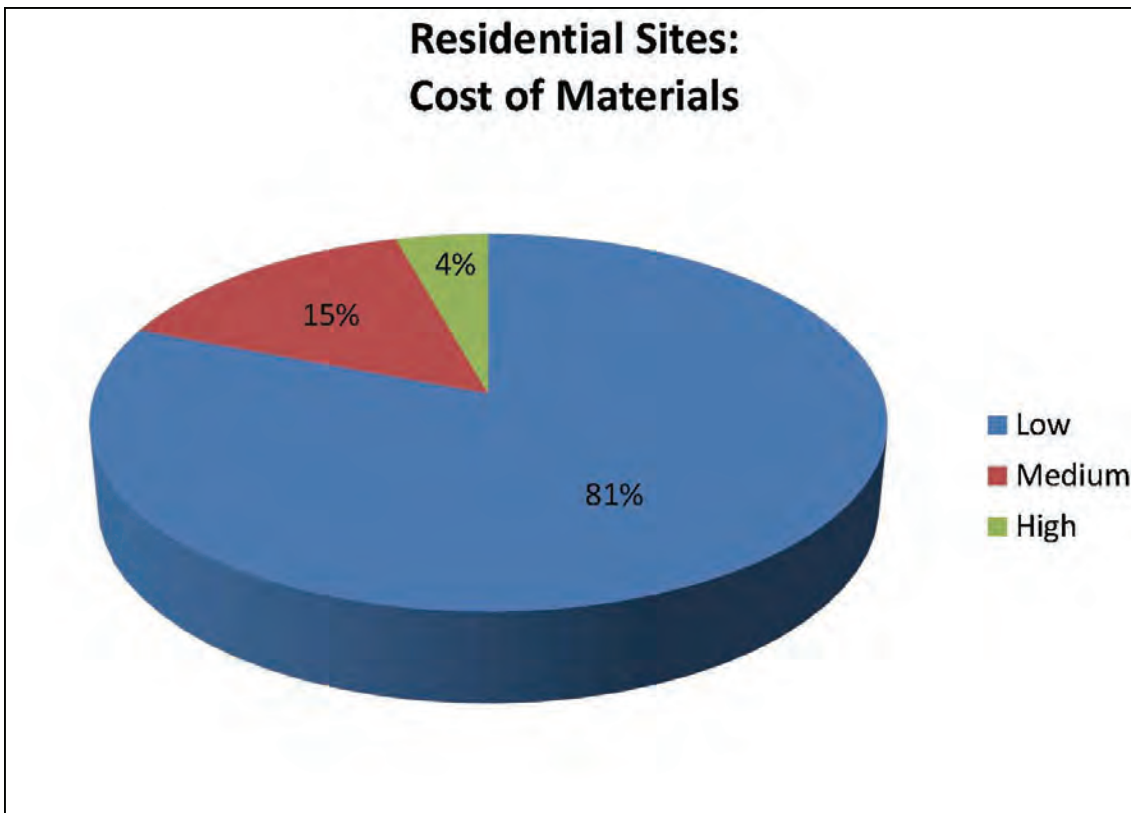
114 out of 115 of the Residential Sites were found to have a low or medium level of technical knowledge needed to install the fixes and 110 of the Residential Sites had a low or medium predicted cost to fix.
